### **Electric Power Lifelines**

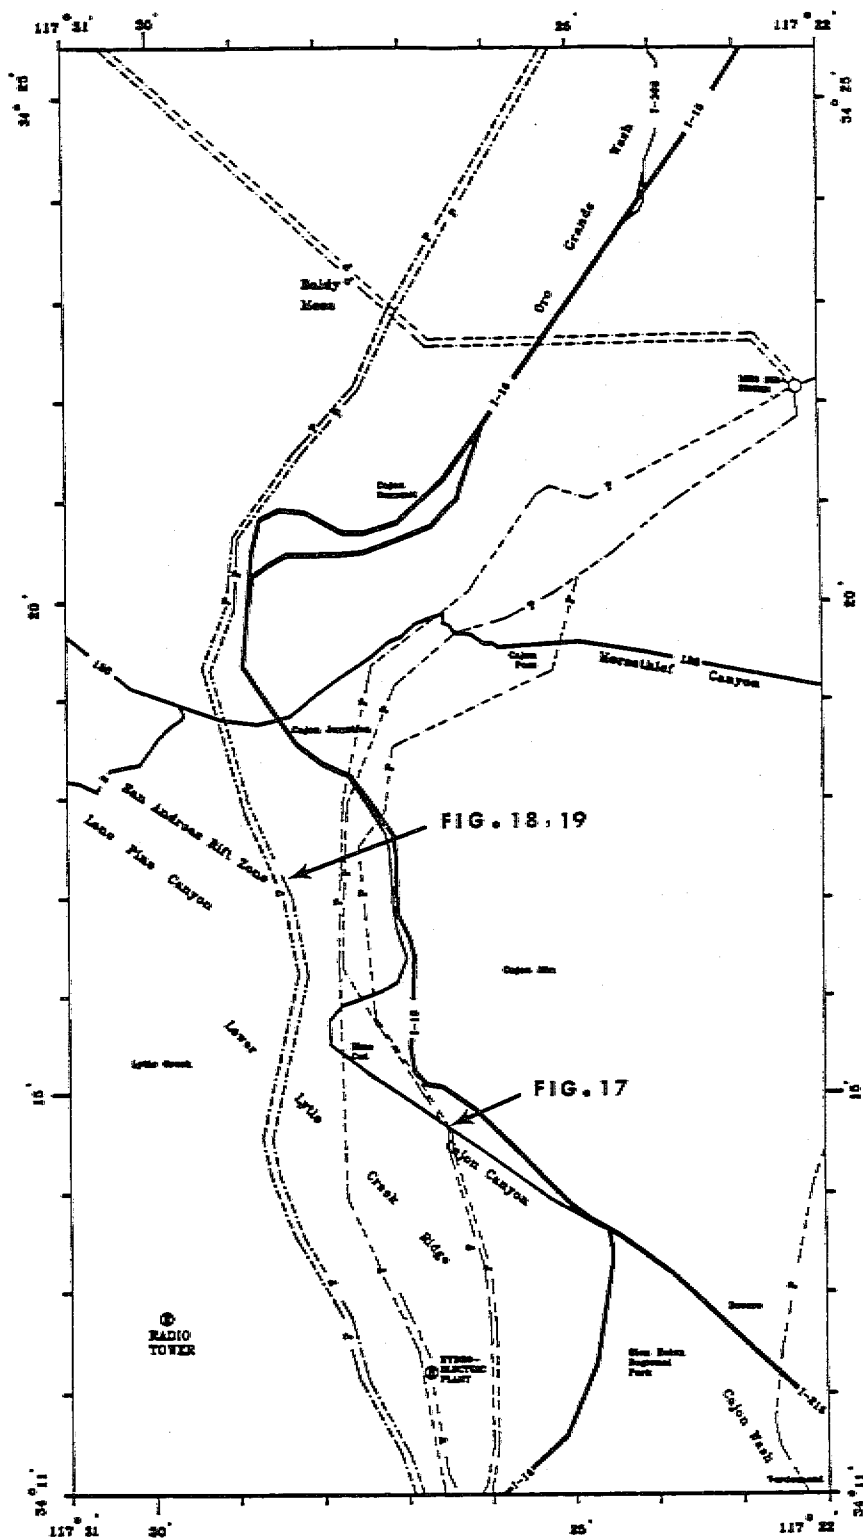
Figure 16, ELECTRIC POWER LIFELINE ROUTES

Figure 16 shows the electric power transmission lifeline routes in the study area. The location of the photographs presented in this section of the report are also shown on the figure. Experience has shown that power transmission towers are quite resistant to earthquake shaking, principally because of the conservative wind loading criteria used in their design. Thus, only fault displacement, landslide, or liquefaction are expected to caused significant levels of damage to the towers.

The electric power lifeline systems include a major transmission system substation at Lugo in the northeast corner of the study area, a hydroelectric generation station in Lytle Creek Canyon, and four major high voltage transmission systems. The hydroelectric station is not collocated with any of the lifeline components of interest to this study. Although the substation is collocated with two of the high voltage transmission systems, component failures in the substation are not expected to lead to transmission line failures, and visa versa. The transmission lines are not expected to have any failures at the shaking intensity expected at Lugo
